# Building Inspection Report

**123 Main St Poughkeepsie, NY**

5/14/2008

20080514-3-doe

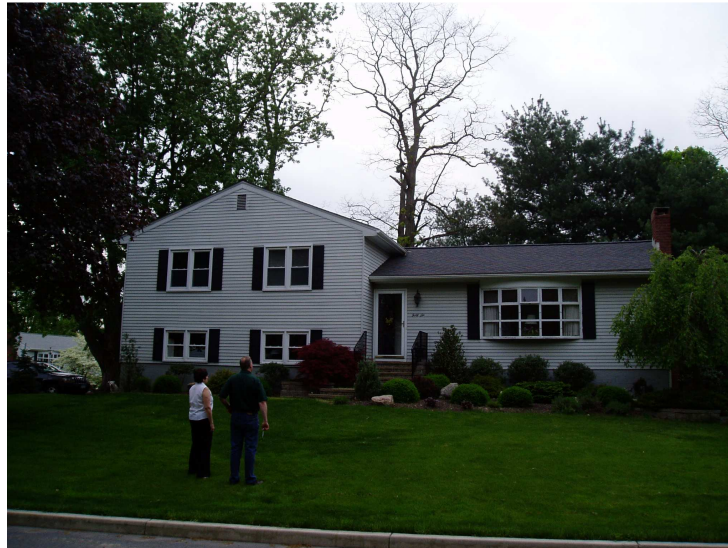
Split Level Built in 1973, 2 Car Attached Garage. House Faces South.

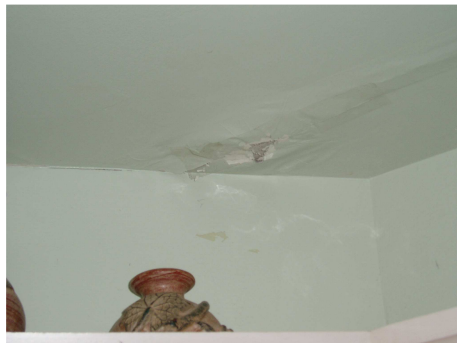
- **Repair:** Minor drywall cracks were noted in the kitchen, living room, and dining room. In the kitchen the crack was located on the ceiling above the sink. In the living room cracks were located under the window and on the ceiling.
- **Monitor:** Typical drywall cracks were noted throughout the home.
- **Repair:** The bay window in the living room needs paint.
- **Repair:** A door stop should be added on the south east bedroom door to prevent damage to drywall.
- **Repair:** The heater cover is not installed in the south west bedroom.
- **Repair, Safety Issue:** The stair handrails are a catch hazard. The railings should be secured back to the wall.

Kitchen Ceiling Crack
